## Mercedes test cut comparison between legacy CNC88 –5 CPU and Calmotion 527F control. March 23, 2016

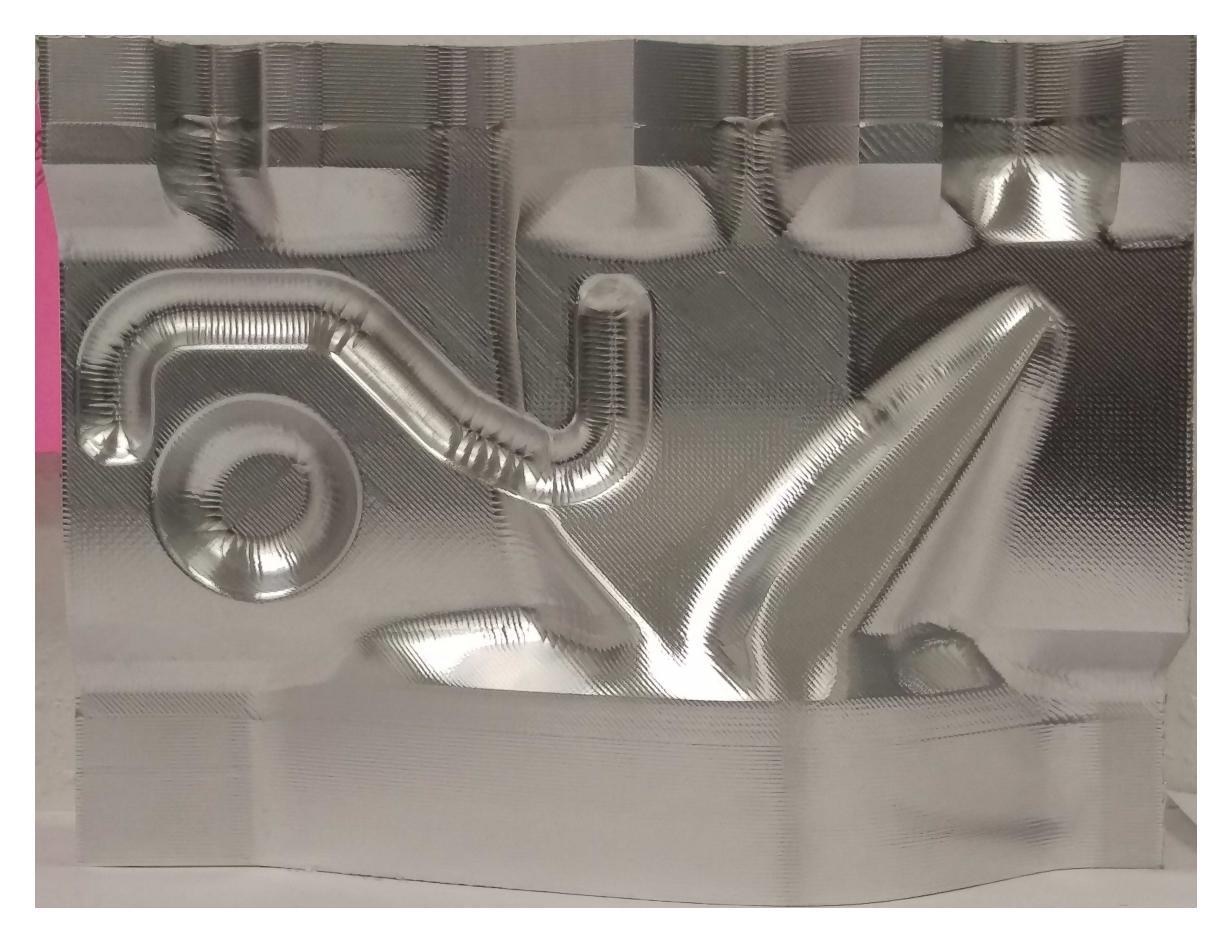
Fadal -5 CPU Mercedes test cut 3200 mm/min

Results: There are minor defects in the parts, however, the surface finish and overall quality of the part is reasonably good.

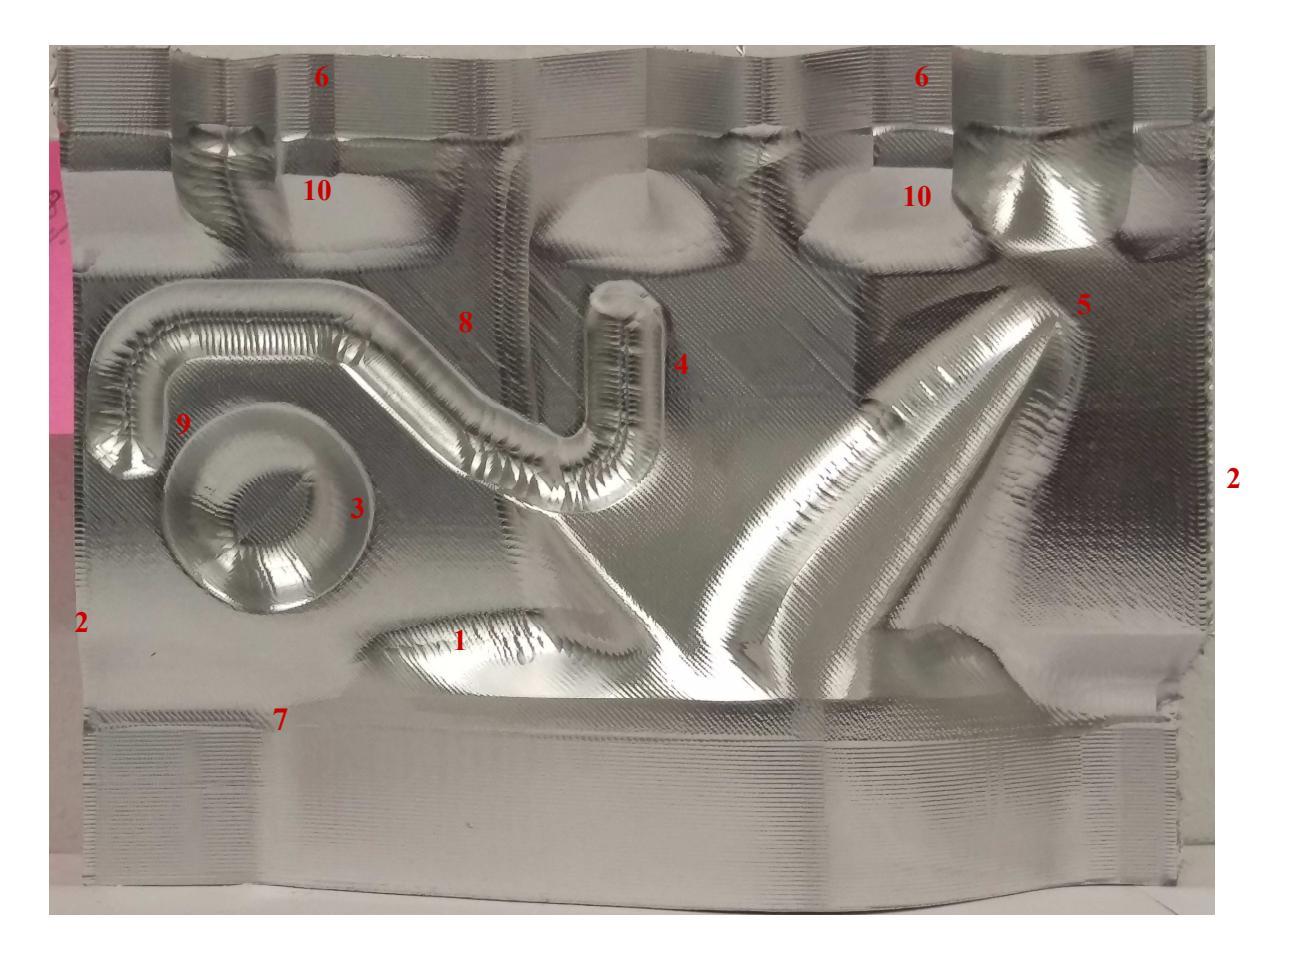
Fadal -5 CPU Mercedes test cut 6400 mm/min

Results: At a higher feed rate, the Fadal –5 CPU begins to falter as evidenced by the distortion of the part integrity.

- 1. Scallop marks appear at several locations on the part
- 2. Due to poor ramp control, the tool reverses on the edges of the part and does not complete the cut.

- 3. One of the features that had a slightly oval shape at 3200 mm/ min now has more of a football shape to it and the fillet edges are misshaped
- 4. Tool marks that were once horizontal, now have a angle to them with less consistent spacing to them

- 5. A feature that was once rectangular is distorted and has developed a pointed tip to it
- 6. Although not visible from a top view, these areas were flat but now have a slight angle to them

- 7. The diagonal cut surface and the adjoining straight direction cut do not properly mesh
- 8. The Z axis does not maintain position at all times during the program and leaves witness marks

- 9. The ends of the slot are no longer round. The fillet edges of the slot are misshaped
- 10. The features that were previously rectangular have lost their shape. In addition to being distorted, the surface to surface intersections are violated.

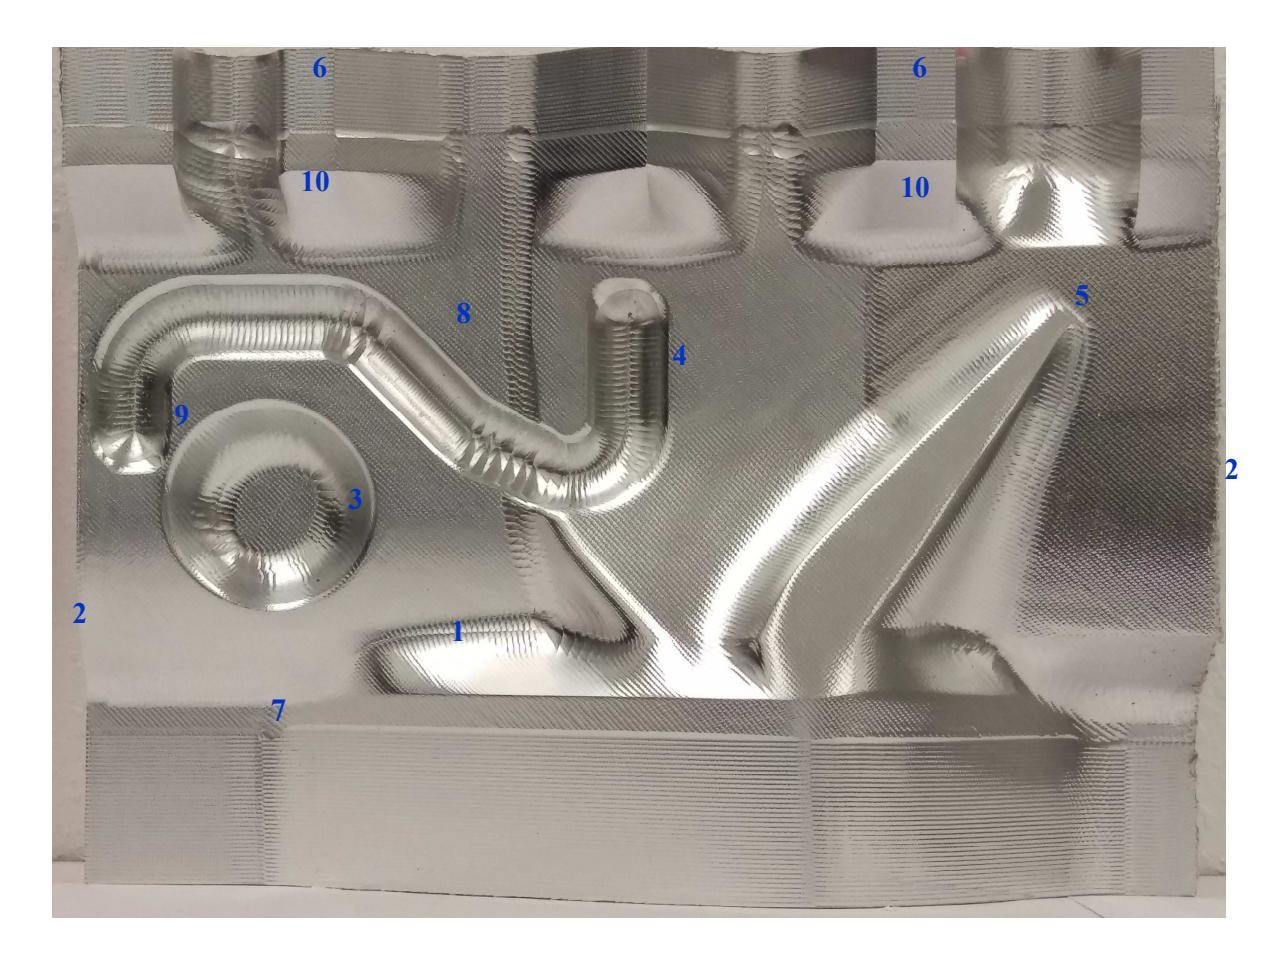
Calmotion 527F Mercedes test cut 6400 mm/min

Results: At a higher feed rate, the Calmotion 527F CNC retains its shape and does not distort the part integrity as the –5 CPU does.

- 1. Scallop marks are not evidenced on the part surface
- 2. With improved ramp control, the tool properly reverses on the edges of the part and completes the cut.
- 3. The features with the slightly oval shape at 3200 mm/ min has not been affected by the higher feed rate
- 4. Tool marks that continue to be horizontal with consistent spacing between them
- 5. A rectangular feature in the part retains its shape and does not develop a point
- 6. Although not visible from a top view, the surface top is flat and has not been distorted
- 7. The surfaces mesh properly
- 8. Uncontrolled Z axis witness marks do not appear at higher feed rates
- 9. The end of the slot maintains a round shape and the fillet edges remain consistent
- 10. The rectangular shape is maintained and there are no surface to surface violations

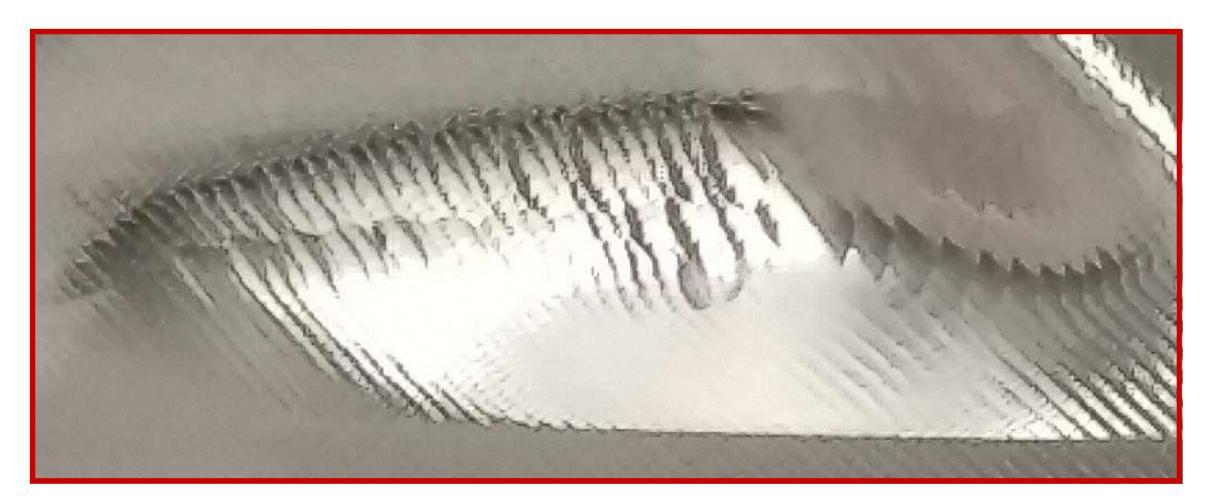
Fadal CPU –5 6400 mm / min Surface integrity compromised

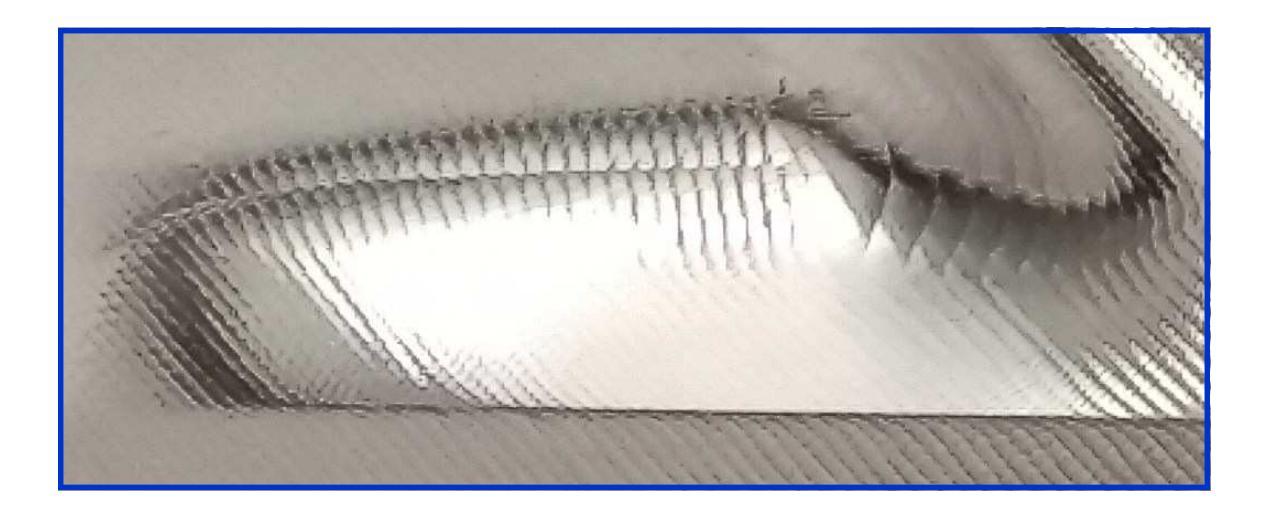
Calmotion 527F 6400 mm / min Surface integrity maintained

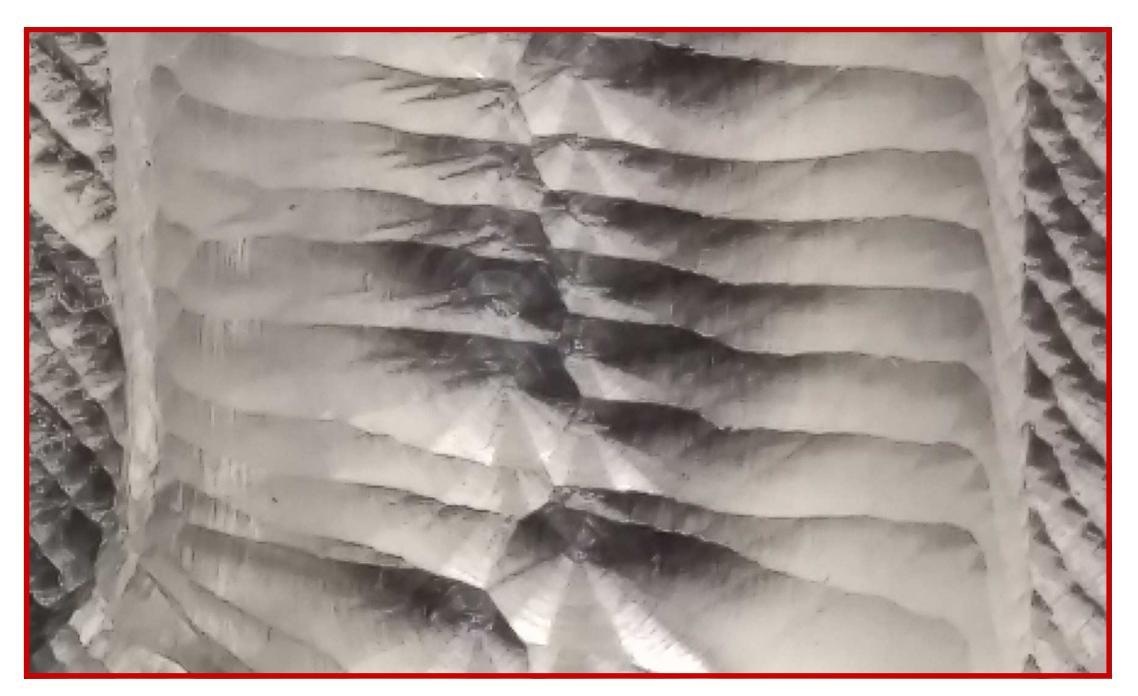
Fadal CPU –5 6400 mm / min Irregular spacing and diagonal tool path

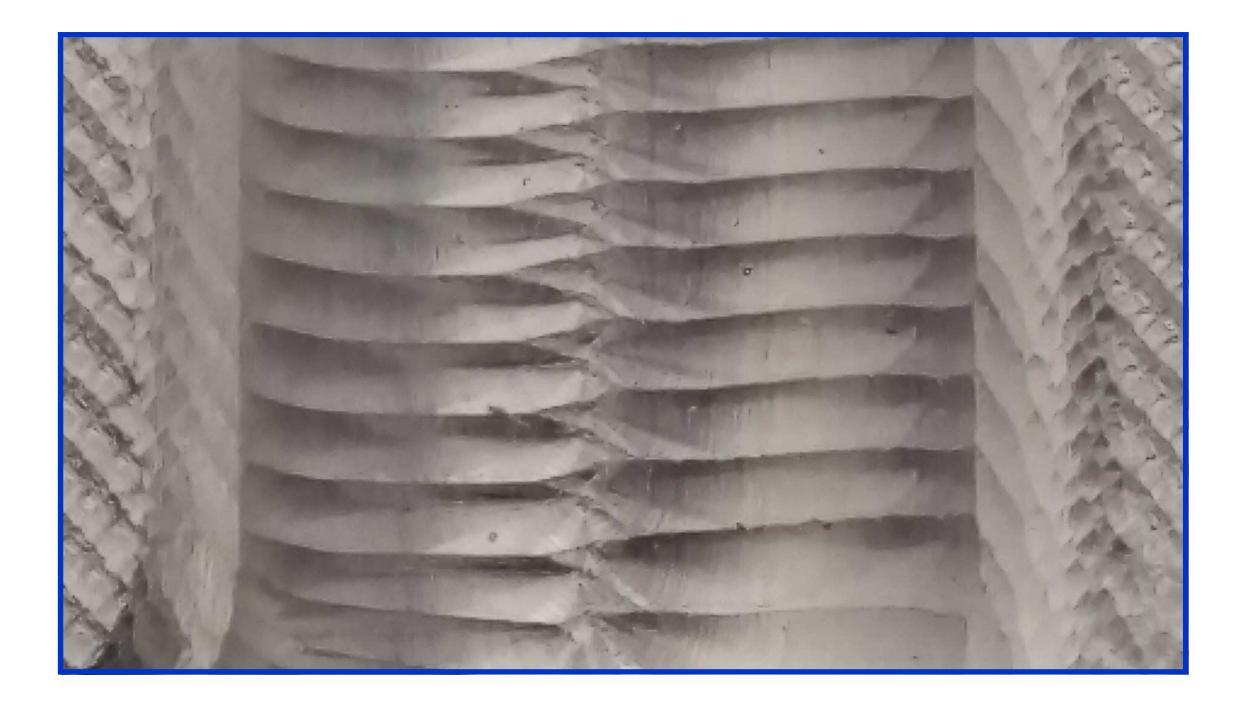
Calmotion 527F 6400 mm / min

Regular spacing with proper tool path

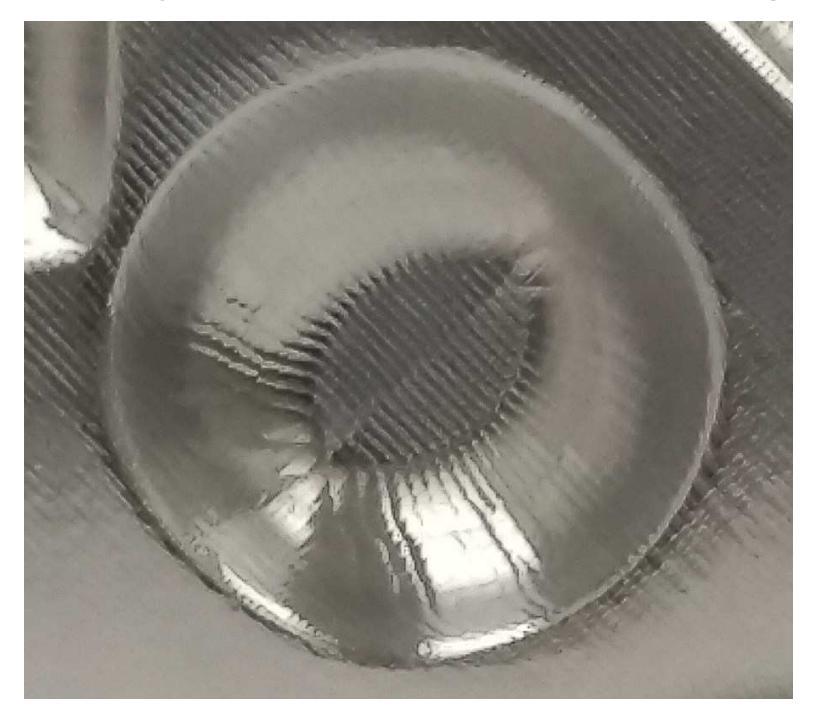
**Fadal CPU –5 6400 mm / min** The oval feature has developed a football shape

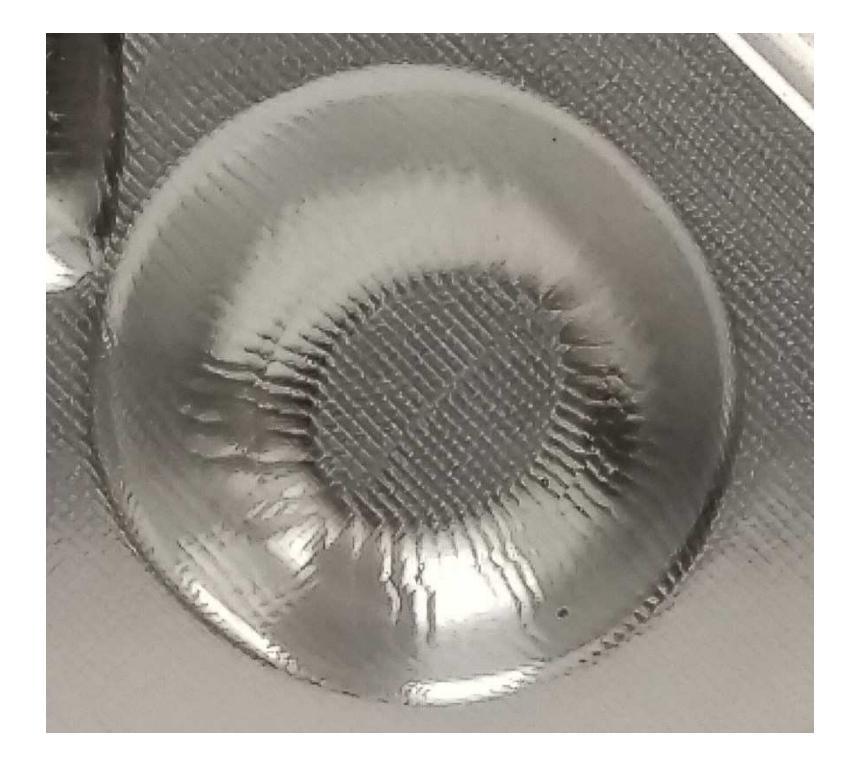
**Calmotion 527F 6400 mm / min** The feature has maintained its shape at a higher feed rate

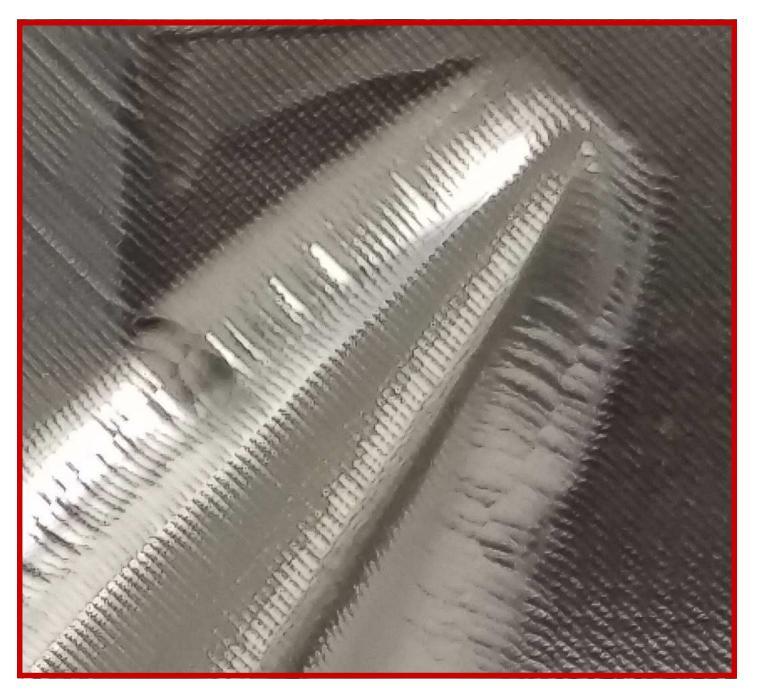
# Fadal CPU –5 6400 mm / min

A feature that was rectangular has developed a pointed tip to it and has scallop marks

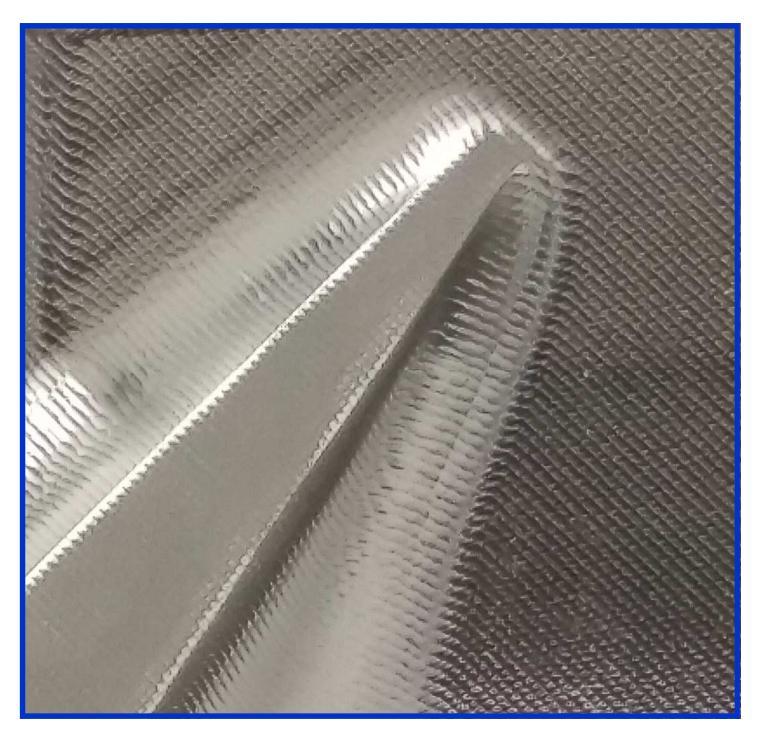
**Calmotion 527F 6400 mm / min** Shape integrity is maintained with good surface finish

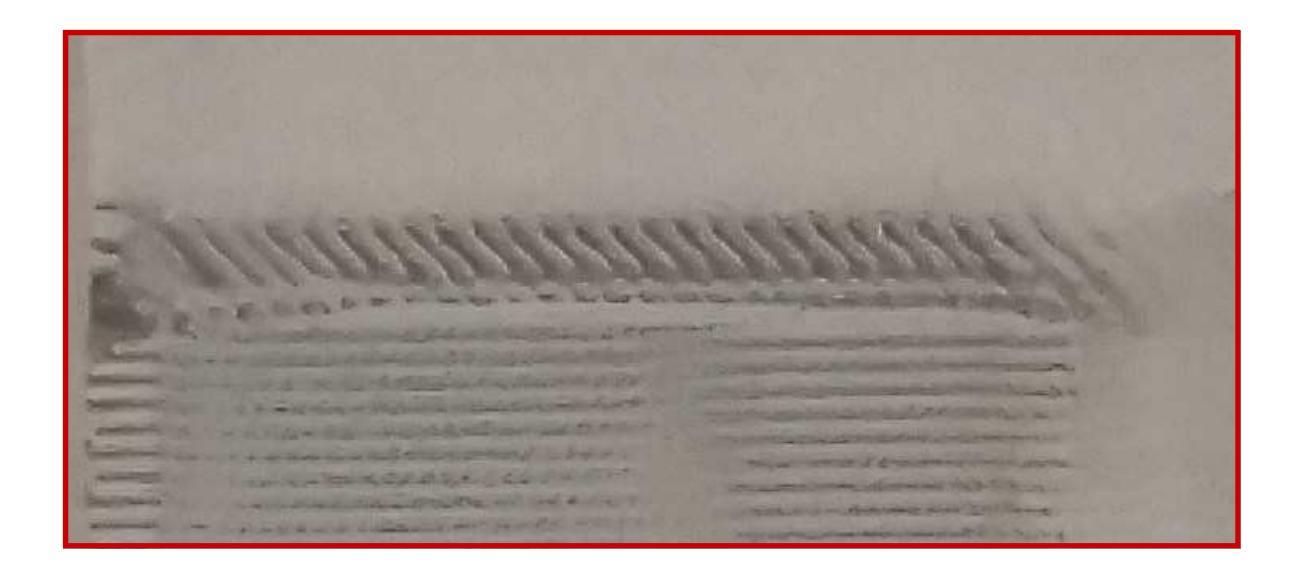
#### Fadal CPU –5 6400 mm / min The tool does not complete its path resulting in the two surfaces not meshing well.

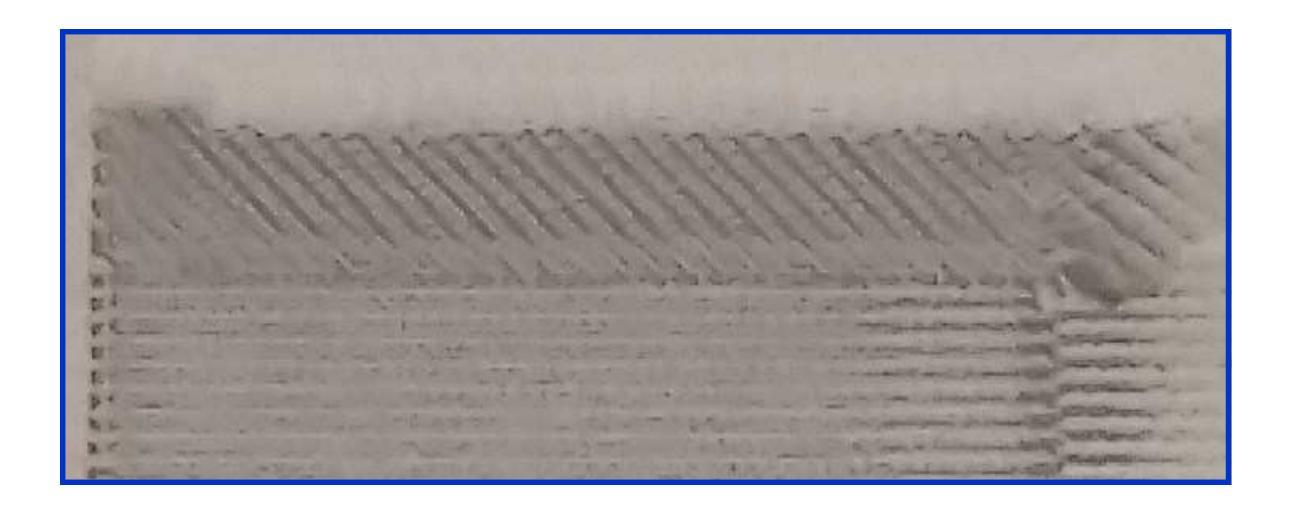
## Calmotion 527F 6400 mm / min

Better ramp control results in proper meshing of surfaces maintained with good surface

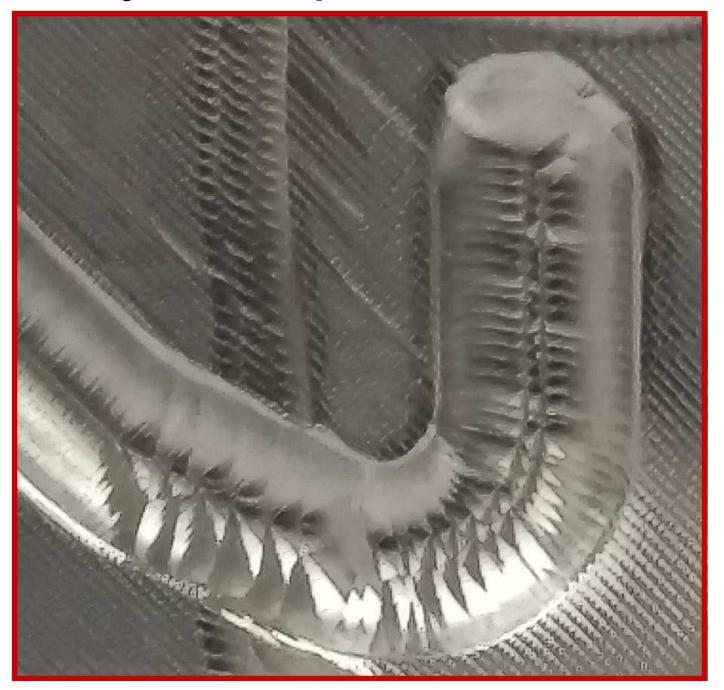
**Fadal CPU –5 6400 mm / min** Diagonal tool path inside the feature as well as Z axis witness marks on the surface

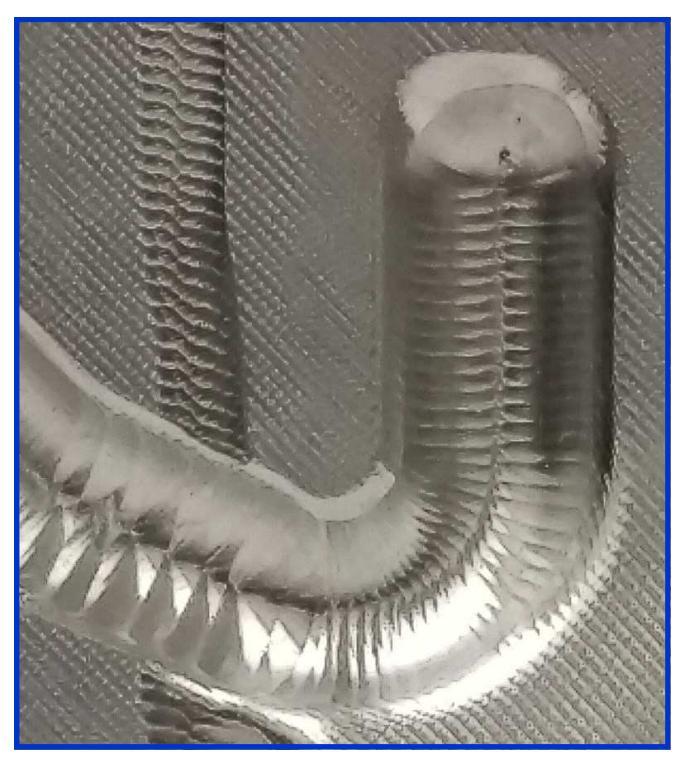
Calmotion 527F 6400 mm / min Horizontal tool path is maintained with good surface finish

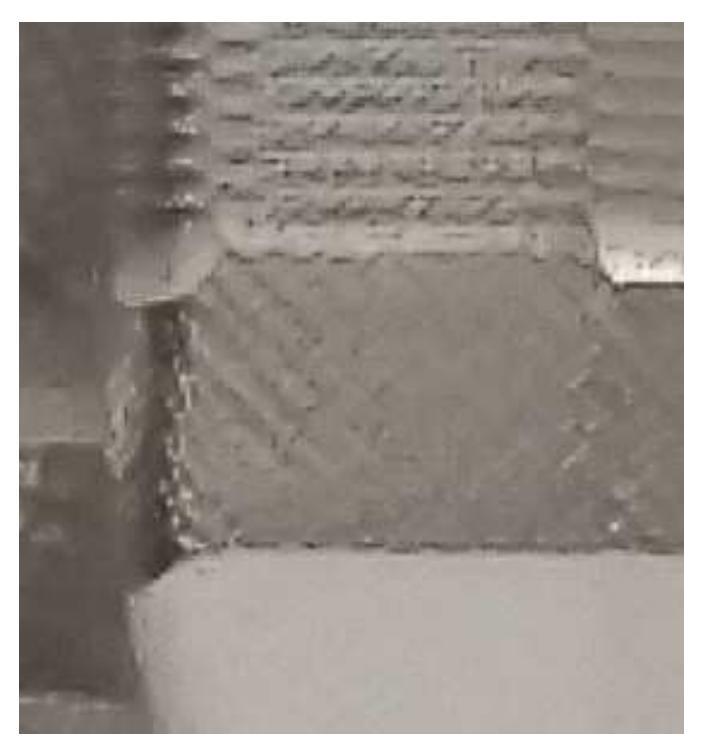
Calmotion 527F 6400 mm / min Rectangular shape is maintained
